Mike Ferry
University of California, Berkeley

Peter Miller
University of California, Berkeley

The removal of Saeltzer Dam on Clear Creek : an update

Mike Ferry and Peter Miller
June 2, 2003

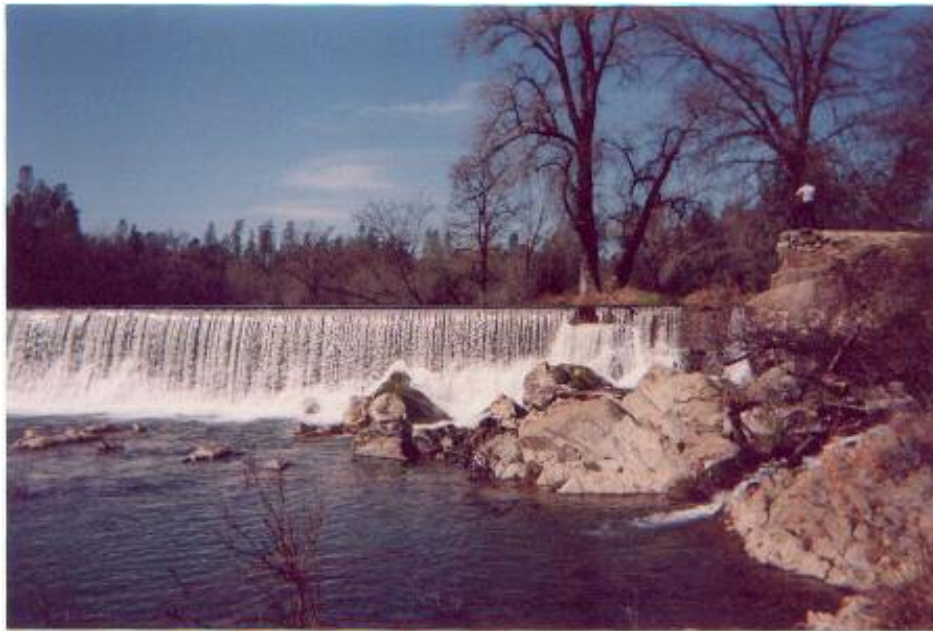
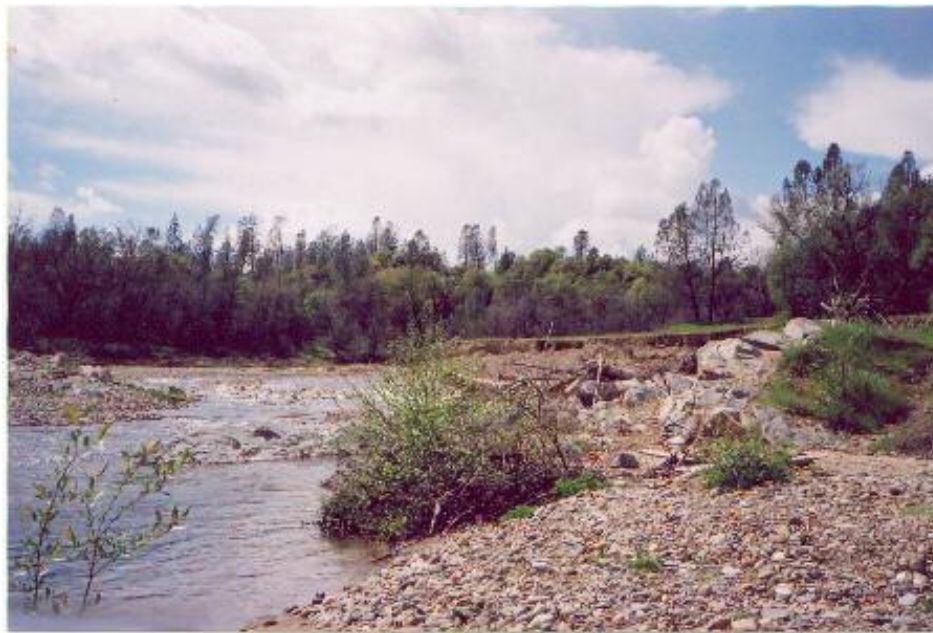
Figure 4: Saeltzer Dam, Before and After Removal, View Upstream

Three pairs of pre- and post-dam removal photographs are presented in Figures 4, 5, and 6. The “pre” photographs were collected as part of the environmental assessment of dam removal and were given to us by Mike Urkov of CH2M Hill (see Table 1). The post-dam photographs were taken by us on April 4, 2003. In each case we attempted to duplicate pre-existing photographs of Saeltzer Dam.
